# Restoration of Forest Riparian Buffer Strips on the Upper Reaches of the Qin River, Shanxi Province

Forest riparian buffer strips have long been recognized for their important functions that include providing shade to reduce water temperature, enhancing deposition of sediments and other contaminants, reducing nutrient loads of streams, stabilizing stream banks with vegetation, reducing erosion caused by uncontrolled runoff, and providing habitats for riparian wildlife. To rehabilitate and reconstruct the riparian buffers at the source of the Qin River in Shanxi Province, China, a field survey and experiments were conducted to provide an example of forest riparian buffer construction in the region. An assessment index system was used to evaluate the Chishiqiao and Zihong rivers, both first-level tributaries of the Qin River. A comprehensive evaluation index system offered indicators of vegetation structural intactness and bank stability including vegetation continuity along the river channel, vegetation coverage and height, abundance of floristic components, associations among vegetation, rock, and soil types, bank structure, and soil erosion modulus. Results indicated that the C

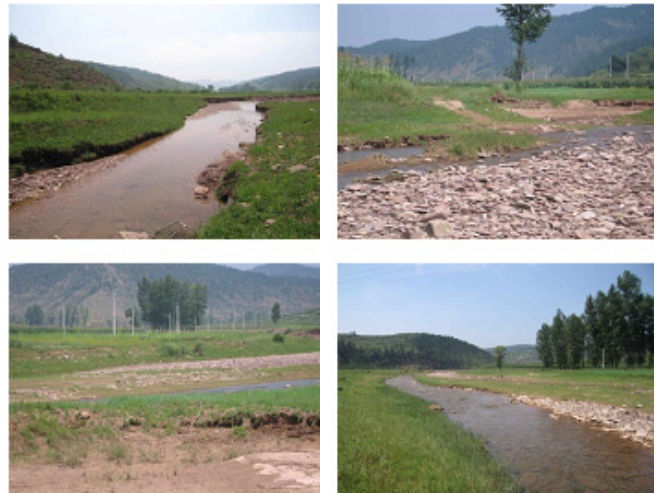
Fig. 3 Photos of sections of the Zihong River (Sections 10<sup>#</sup>-13<sup>#</sup>).

The field survey was conducted from March to April, 2007. Nine transects near the source of the Chishiqiao River (1<sup>#</sup>–9<sup>#</sup>) (Fig. 2) and four transects near the source of the Zihong River (10<sup>#</sup>–13<sup>#</sup>) (Fig. 3) were surveyed. These transects were 30–50 m in width, and chosen random from one of the sections of the riparian.

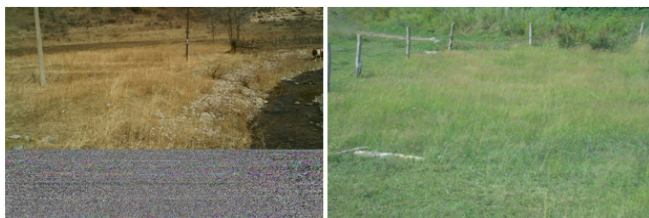
Fig. 4 Pre- and post-project comparison in the PG plot.

PG: *Salix matsudana* survived about 15 days after planting. The height and density of vegetation in the treatment plot (1#) were significantly higher than those in the control plot (2#) (**Fig. 4**).

PG: This area was dominated by perennial grasses (>80%) including *Pennisetum flaccidum* Griseb and *Carex rigescens*. The reclamation methods included: 1) planting eight Willow (*Salix matsudana*, an indigenous shrub) seedlings; and 2) installing a 1.5-m high fence around the treatment plot (1#) to exclude livestock and people, which was paired with a control plot (2#) without a fence.

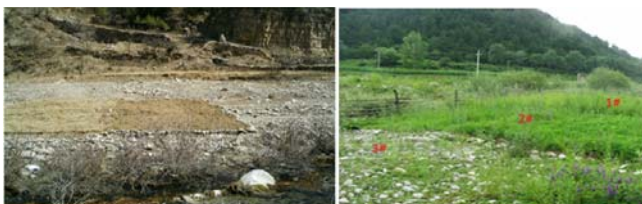
Fig. 5 Pre- and post-project comparison in the RI plot.

RI: Growth of vegetation in 1# was the greatest of the three plots. Both fencing and turfing effectively improved the condition of the vegetation, and mulching also had a small effect. Vegetation height and density were greater in 1# and 2# than in the control plot (3#) (**Fig. 5**).

RI: The ground cover was composed of riprap with sparse vegetation. Vegetation is difficult to regenerate in such plots, which are common in riparian areas of the Qin River. The two types of reclamation methods included: 1) overlaying with 15 cm of soil, turfing (*Pennisetum flaccidum* Griseb, *Carex rigescens*), and fencing with a 1.5-m high fence; and 2) applying soil to a depth of 15 cm to treatment plots (1# and 2#) paired with an untreated control plot (3#).

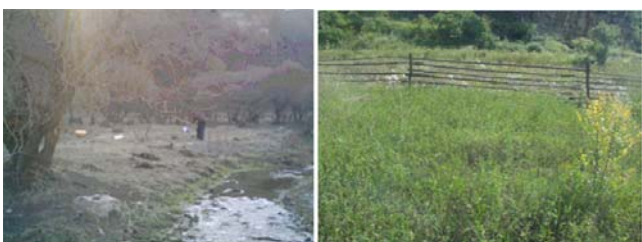
Fig. 6 Pre- and post-project comparison in the PS plot.

PS: *Salix matsudana* survived approximately 15 days after planting. Vegetation height and density in the treatment plot (1#) were significantly greater than that in the control plot (2#) (**Fig. 6**).

PS: About 30% of vegetation consisted of shrubs (*Salix matsudana*), and about 10% were grasses (*Pennisetum flacidum* Griseb, *Carex rigescens*, wormwood). The reclamation methods included: 1) planting 15 willow (*Salix matsudana*) seedlings; and 2) installing a 1.5-m high fence to exclude livestock and people.
